### Causal Analysis Report

### Chevron Richmond Refinery Reportable Flaring Events

November 2-3, 2020

Flaring Due to Power Loss at #2 and #4 Substations

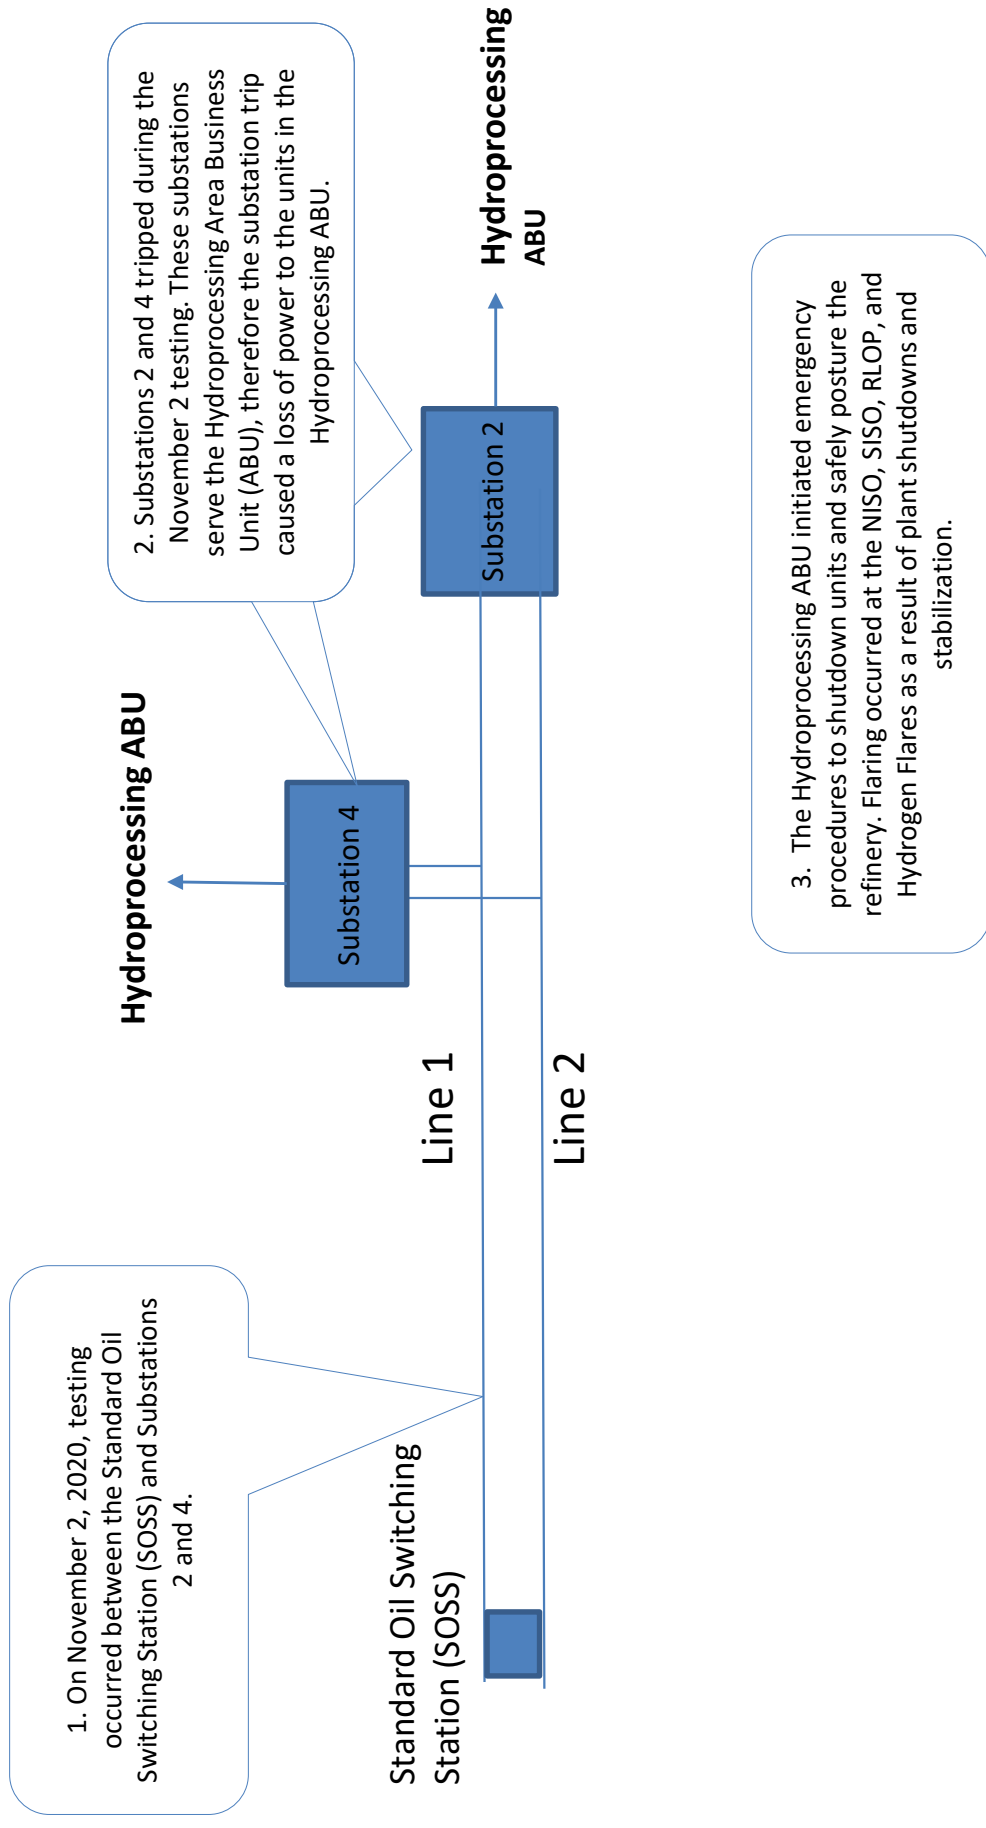
# Power Outage

On November 2nd, 2020, during testing of the tone-based communication system between the SOSS (Standard Oil Switching System) and two electrical substations (#2 and #4), a trip of the substation breakers caused a loss of power to the Hydroprocessing ABU (Area Business Unit). This was due to an incorrectly labeled drawing that did not match the circuitry in the field. Loss of power to units in the Hydroprocessing Area Business Unit led to process gases being sent to the relief system. Flaring began at approximately 12:57 PM at the North Isomax (NISO) flare. The primary source of vent gas flared during this event was process material from the multiple units in the Hydroprocessing Area Business Unit. Operations immediately responded, resetting and reenergizing the system to allow the area operators to begin restoring the units. Flaring stopped on November 3rd, 2020 at approximately 5:35 AM. The sulfur dioxide (SO<sub>2</sub>) emissions from the RLOP, NISO, and SISO flares exceeded 500 pounds (lbs) within a 24-hr period, and the vent gas volume from the NISO, RLOP, SISO, and H2 flares exceeded 500,000 SCF within a 24-hr period.

Root cause: Activation of relay.

Contributing factor: Elementary diagram drawings utilized did not correctly reflect wiring in the field.

Contributing factor: The activated relays are auxiliary relays. Labels were incorrect/not clear.

The main contributor of vent gas flow during this event originated from multiple units in the Hydroprocessing ABU.
